Report from LWDA Site Field Trips

Dates: 11/26-30/07; 01/17/08

Henrique Schmitt, Brian Hicks, Ken Stewart, & Tracy Clarke
Naval Research Laboratory

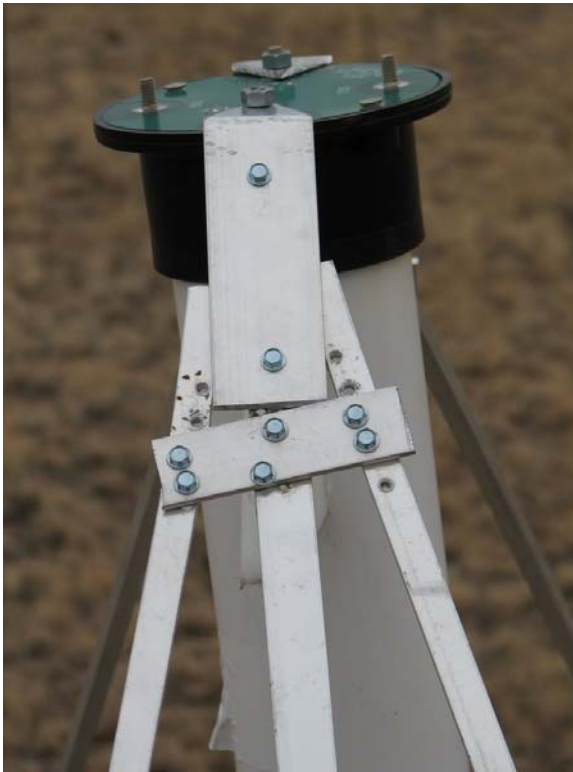
baluns. While making these changes the team noted that the 8 pre-installed RTA-2 antennas were unacceptably inhomogeneous (Fig. 1). For example, it was necessary to file the ends of the brackets to eliminate fragments of aluminum that would otherwise pose a hazard to the active baluns. The position of the top bar of the antennas (in another unexpected design deviation) was at odd angles, often making it hard to attach the brackets. Furthermore, the three aluminum rods that constitute the main body of the blade did not always properly converge at the apex, an indication of unwanted incongruous opening angles. A second set of 12 new antennas (8 for RTA-2, 4 for RTA-1) were brought to the site and installed on Friday (11/30/07) by a UNM team including Eduardo Aguilera, Ylva Pihlstrom, Masaya Kunyioshi and David Martin. These antennas (see Fig. 2) were much more homogeneous and generally reflected much better craftsmanship than the pre-installed first set of 8 RTA-2 antennas.

Figure 1: Example of inadequate RTA antenna construction.

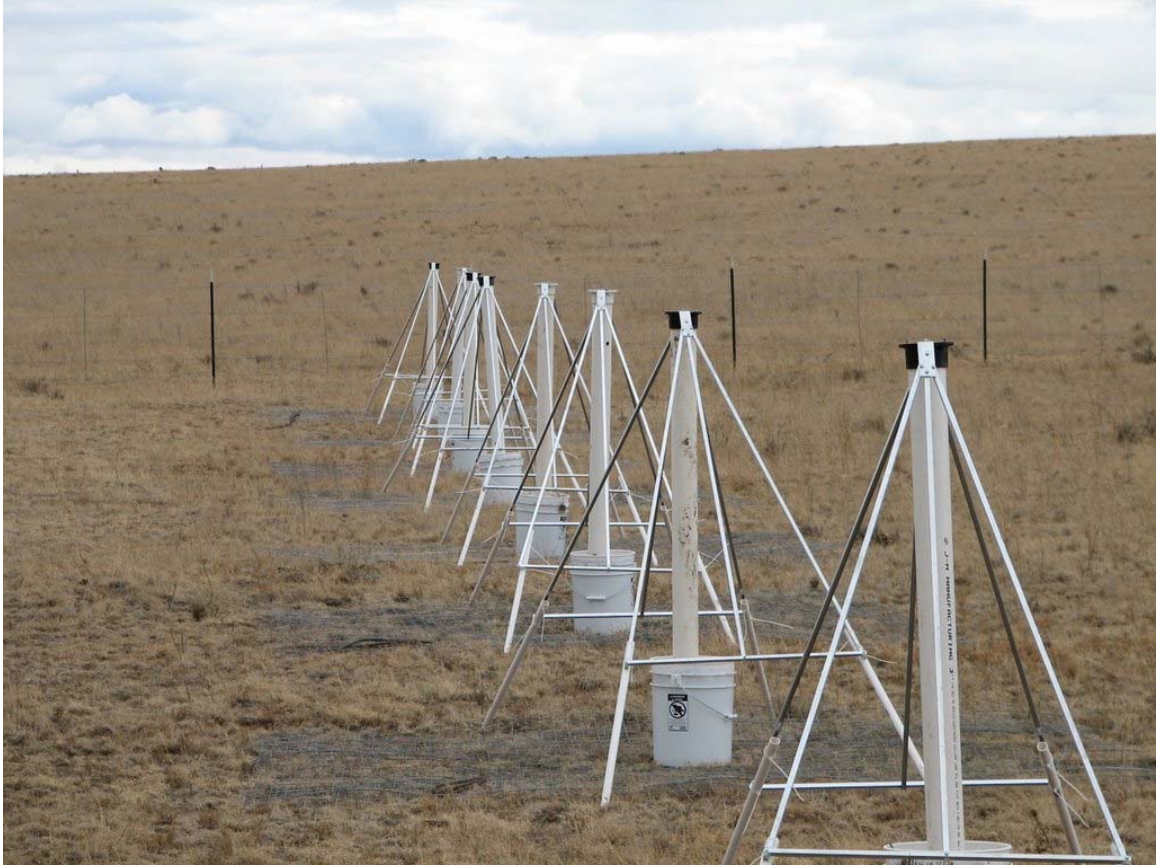
Figure 2: Single row of reconstructed and improved RTA-2 antennas. Unfortunately the improvised anchoring system using buckets of sand failed after a strong wind storm.

- 8) Deviations in pre-planned design and deployment activities must only be adopted after careful review and preferably advanced field testing. For example the improvised technique of anchoring antennas using buckets of sand failed in the first high wind storm.

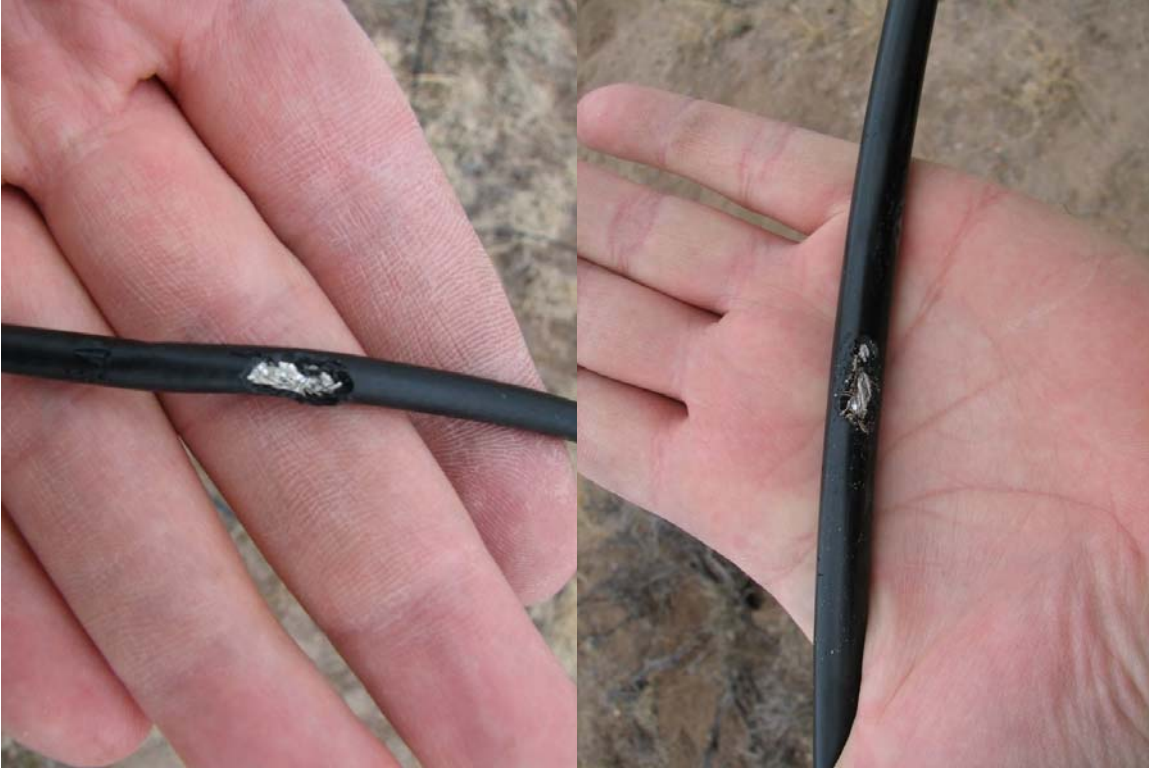
An inspection of the 8 x 30m LMR200 cables available at the RTA-2 site showed that 7 of them had been chewed by animals and some of them also had severe kinks (see Figs. 5-7). In some cases the holes affected only the outer mesh, but in most the cuts penetrated to the inner part of the cable rendering it unusable. Samples were brought back. The assumption is that these cuts were probably caused by rabbits (or other rodents). In the case of the kinks, the origin is less clear, but they may have been caused by the same cattle that destroyed an earlier initial deployment of 4 RTA-2 antennas. The team also inspected the 2 x 300m LMR400 cables running from the electronics shelter to the RTA-2 outlier site and discovered that they had also been chewed, particularly close (between 15 and 50 m) to the RTA-2 fence. The NRL team also determined that one of the cables *inside* the LWDA enclosure was chewed, specifically the cable going from the shelter to BB3, just outside the point where the cables leave the PVC conduit. It may be possible to substitute this cable with LMR240 (previously utilized at the NLTA) available in the shed during a future field trip.

Figure 5 (left) and 6 (right): Examples of cable damage from animals.

A clear lesson was the need to protect all above ground cabling inside suitably rugged conduit (or by other means), including those extending at least 1 foot above ground. This was because in some cases the damaged cable segments extended at least that high above

- 1) Contrary to prior experience, laying exposed co-axial cable above ground, even within fenced enclosures such as the LWDA site, is not an option for the LWA project. Moreover, the evidence of extensive under- and above-ground rodent activity indicates that *all* LWA cabling likely needs to be enclosed in rugged conduit or otherwise protected.

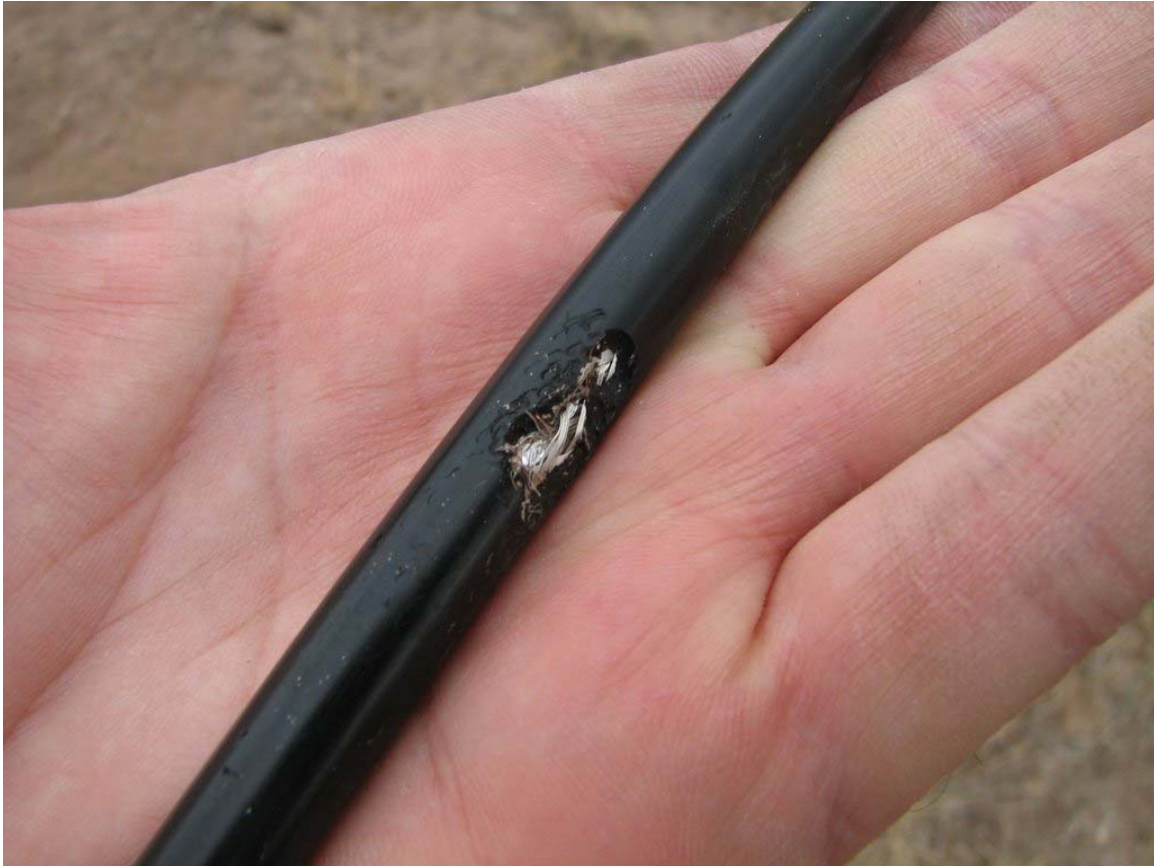
Figure 7: Another example of cable damage from animals.

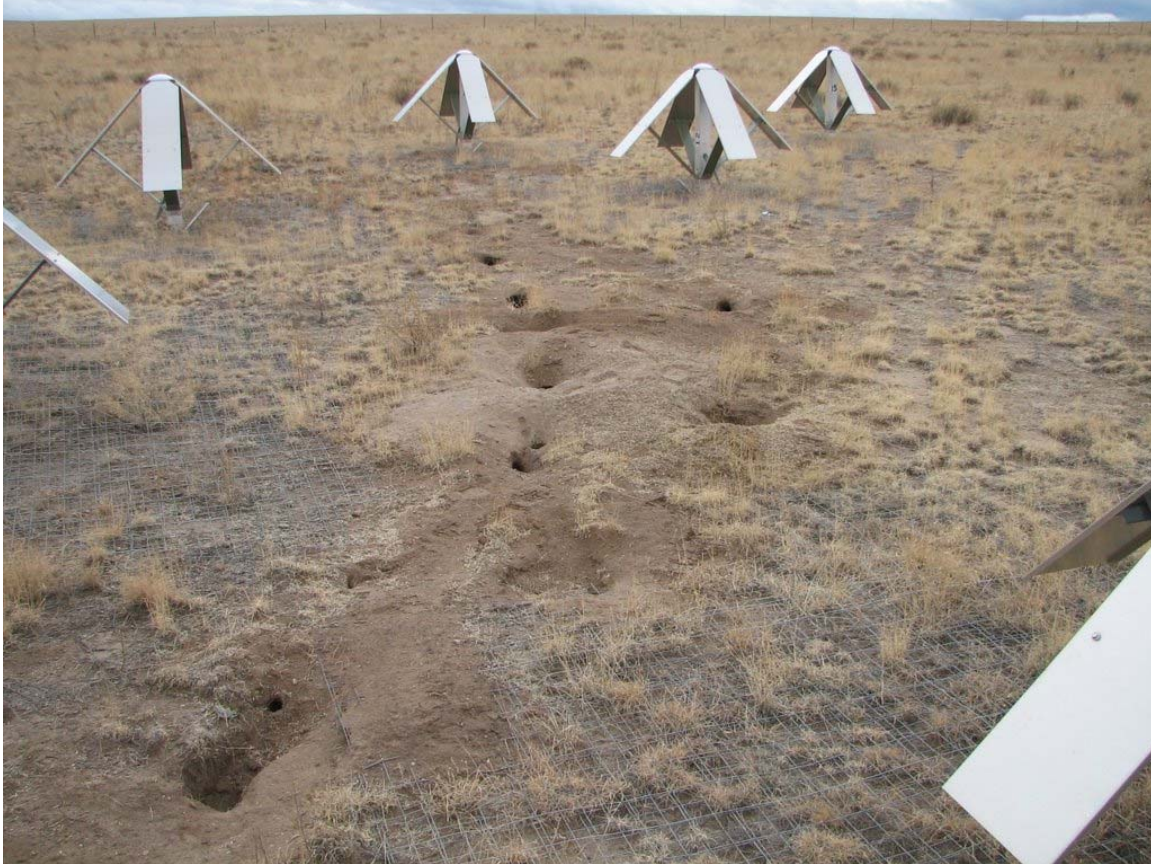
A check of the LWDA infrastructure indicated that everything was in order with all visible hardware intact and undamaged. However, the team discovered a set of large holes on the ground, close to the center of the array, indicating that a family of rabbits, prairie dogs, gophers, or related species, had recently been active there (Fig. 8). No damage from their activity was readily visible, though it is not clear what kind of damage they may have caused underground, either now or in the future. It reinforced the lesson that it is probably necessary to install all future LWA cables in conduit, both above and below ground.

Figure 8: Example of digging activity near the center of the LWDA site. There is currently no evidence of any damage, either above or below ground, to the conduit-protected cabling associated with the LWDA.

- 3) Significant burrowing activity associated with buried conduits is present and increasing at the site, although there is currently no evidence for any underground damage to conduit-protected cabling.

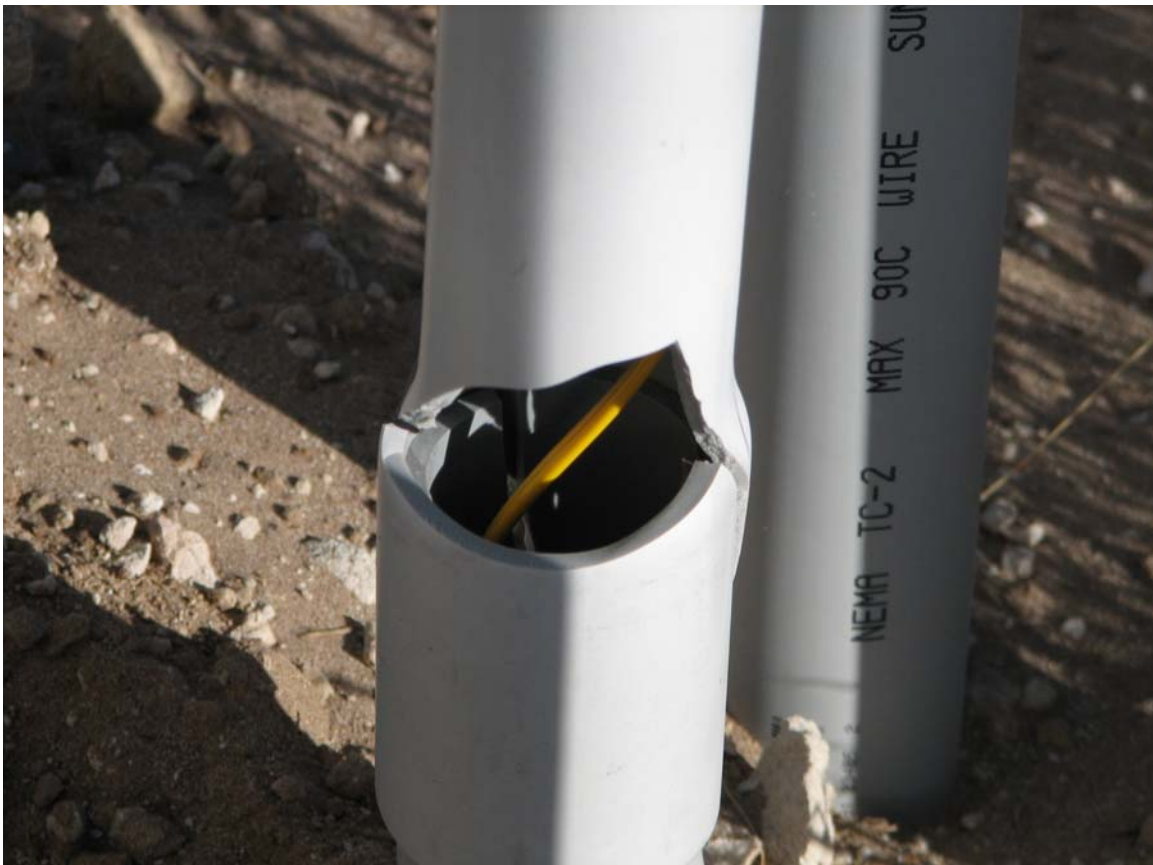
During a one-day follow-up visit to the site on January 17, 2008, Tracy Clarke and Henrique Schmitt noted the following issues. The PVC pipe covering incoming cables at the LWDA site, by the power meter, was broken, exposing the cables (Fig. 9). They suspect the pipe may have been broken by an animal digging a hole under the shed. They also noticed that in some places there were holes dug along the buried pipes, although in that case they did not notice any damage to the pipes (Fig. 10).

Figure 9: Broken PVC pipe covering incoming cables at LWDA site.

- 2) At least one example of above ground broken PVC pipes now exists at the site. Until the source of the damage is understood, future deterioration of PVC-based infrastructure probably can be expected.

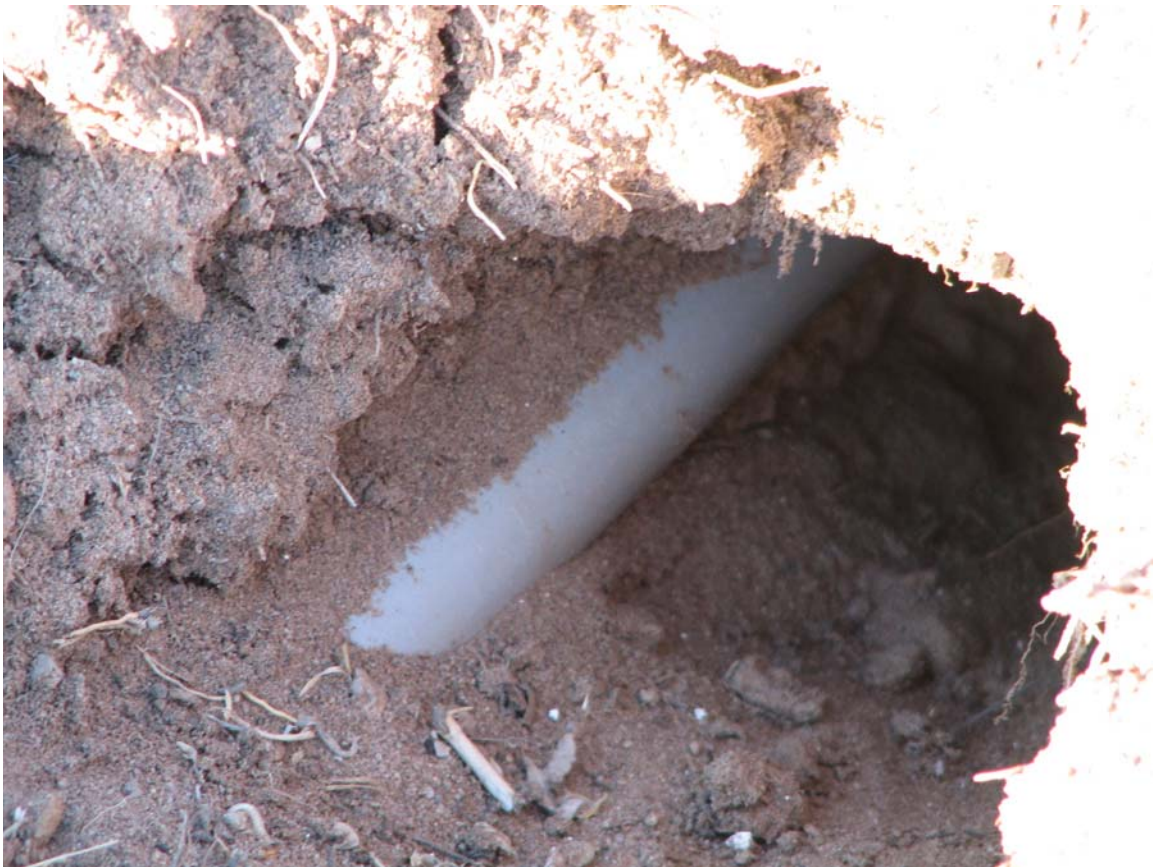
Figure 10: Example of holes dug around buried pipes associated with the LWDA.

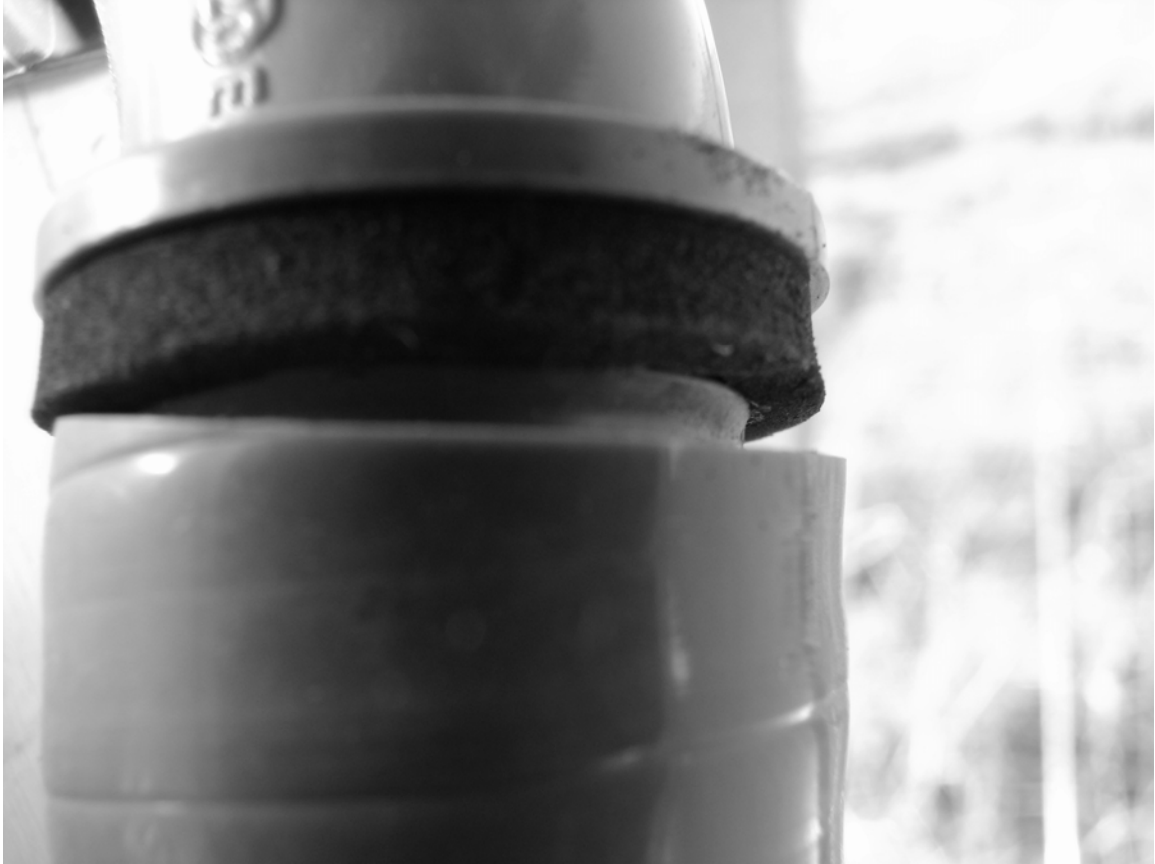
An inspection of the LWDA antennas showed that, in some cases, the sealant at the ends of the conduit covering the cables may be degrading and getting disconnected from the

Figure 11: Example of sealant coming loose at conduit joint.

- 4) Sealant associated with LWDA conduit joints is deteriorating.
- 5) The LWDA itself continues to prove very rugged and has sustained little if any damage. However various nuts and bolts are loosening up with notable implications for future deployments of much larger numbers of antennas.
