# LWA Front End Electronics Repair Guide Ver 1.1

Craig Taylor, Sarah Chastain, Aaron Cross

November 6, 2023

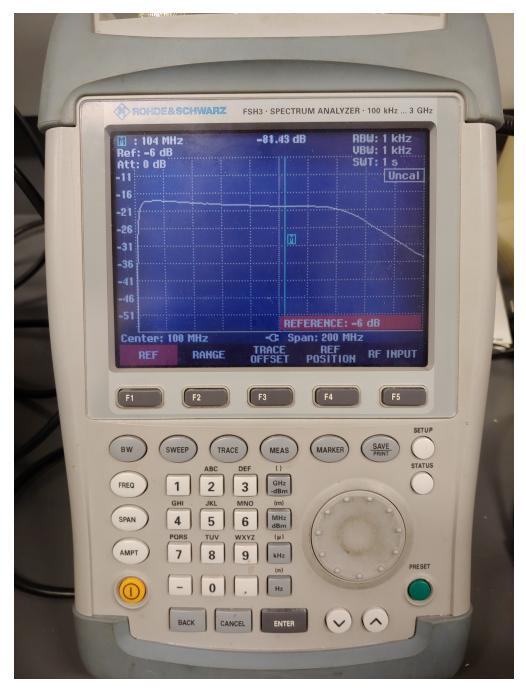
- 3. Power the board then inspect the band-pass response on a spectrum analyzer to check for irregularities. You may reference the response by comparing to Figure 3., or by first placing the 'Control Board' on the fixture and saving the response in Trace Memory on the spectrum analyzer.

**Figure 3:** Spectral response of an optimally performing FEE board as measured using the set-up in Fig. 1. Coverage of the LWA FEE bandpass is displayed at a center frequency of 100 MHz with a span of 200 MHz. In this particular case, 47 dB of attenuation is applied between the spectrum analyzer and FEE fixture.

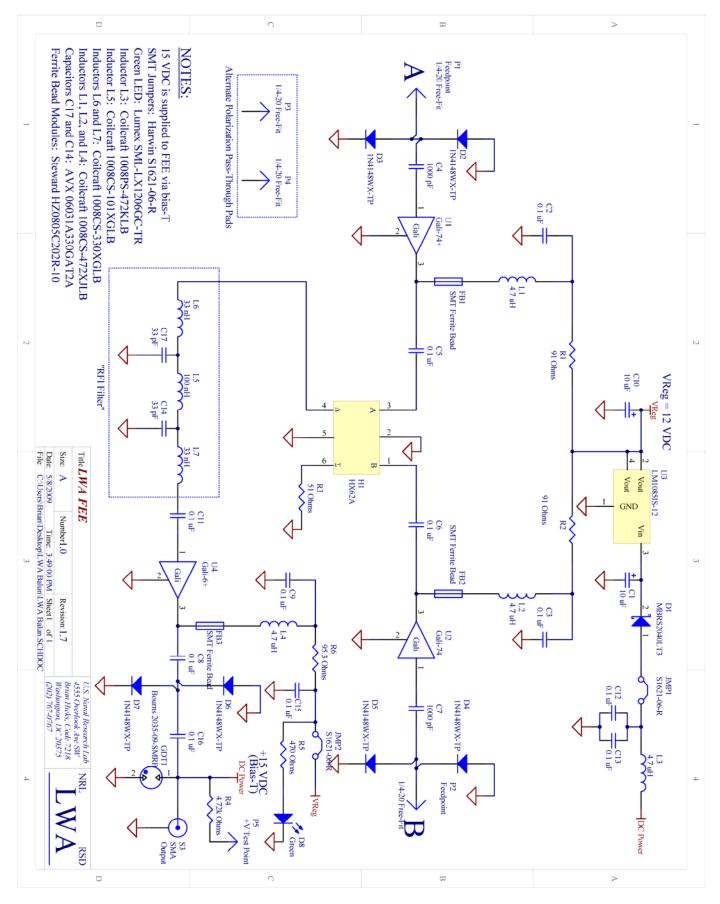
Figure 1 – Updated Schematic of the LWA FEE (Version 1.7)

- 1. L3 has been replaced with a component from Coilcraft (1008PS-472KLB) that is rated for higher current (900mA). The previous part was subject to long availability lead times and was marginally acceptable in terms of current rating. Suspicious failures of the previously specified part were observed.

- 2. The inductors used in the bias networks (L1, L3, and L4) of the 'Gali' amplifiers have also been changed to a component from Coilcraft (1008CS-472XJLB). The new part is more readily available and less expensive than the previous component (\$0.81 versus \$0.20, each). A PCB layout change was not required.

- 6. The coupling capacitors (C4, C7) at the feedpoints have been changed from 0.1 µF to 1000 pF.
- 7. Final assembly instructions and manufacturing details for dual polarization FEEs can be found in EM-FEE0023.
