LWA Memo 224:

LWA Front End Electronics Repair Guide

Ver 3

January 8, 2026

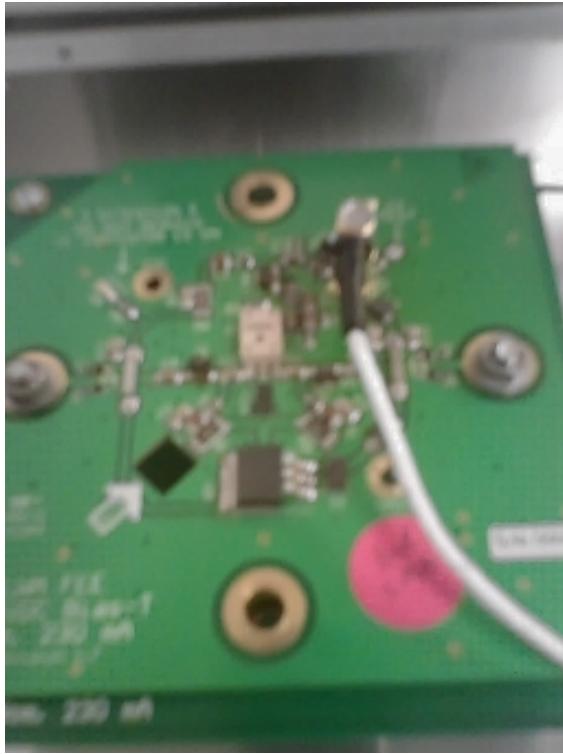
(i) Standard optical image of an LWA FEE board under inspection. No obvious visual damage is present.

Figure 1: Comparison of optical and infrared thermal imaging of an LWA FEE board. Thermal imaging reveals a component heating that is not apparent during visual inspection.

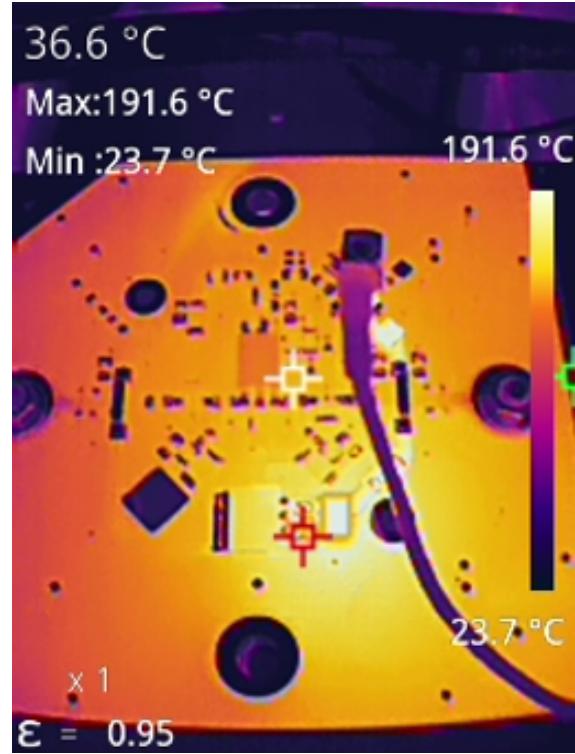
8. After replacing those, check the resistance of the Voltage regulator (U3), and replace if need be.
9. Next, check the capacitors nearby the Voltage regulator (C1 and C10), again replacing if need be. C1 and C10 fail very frequently and may show as “no power” on the board. A fast way to confirm a failure is to use an infrared thermal camera: a bad capacitor often appears unexpectedly hot when power is applied. Figure 1 shows a comparison between a standard optical image and an infrared thermal image of the same FEE board.

(ii) Infrared thermal image of the same board under power, showing localized heating consistent with failing component.
