Report from LWDA Site Field Trips

Dates: 11/26-30/07; 01/17/08

Henrique Schmitt, Brian Hicks, Ken Stewart, & Tracy Clarke
Naval Research Laboratory

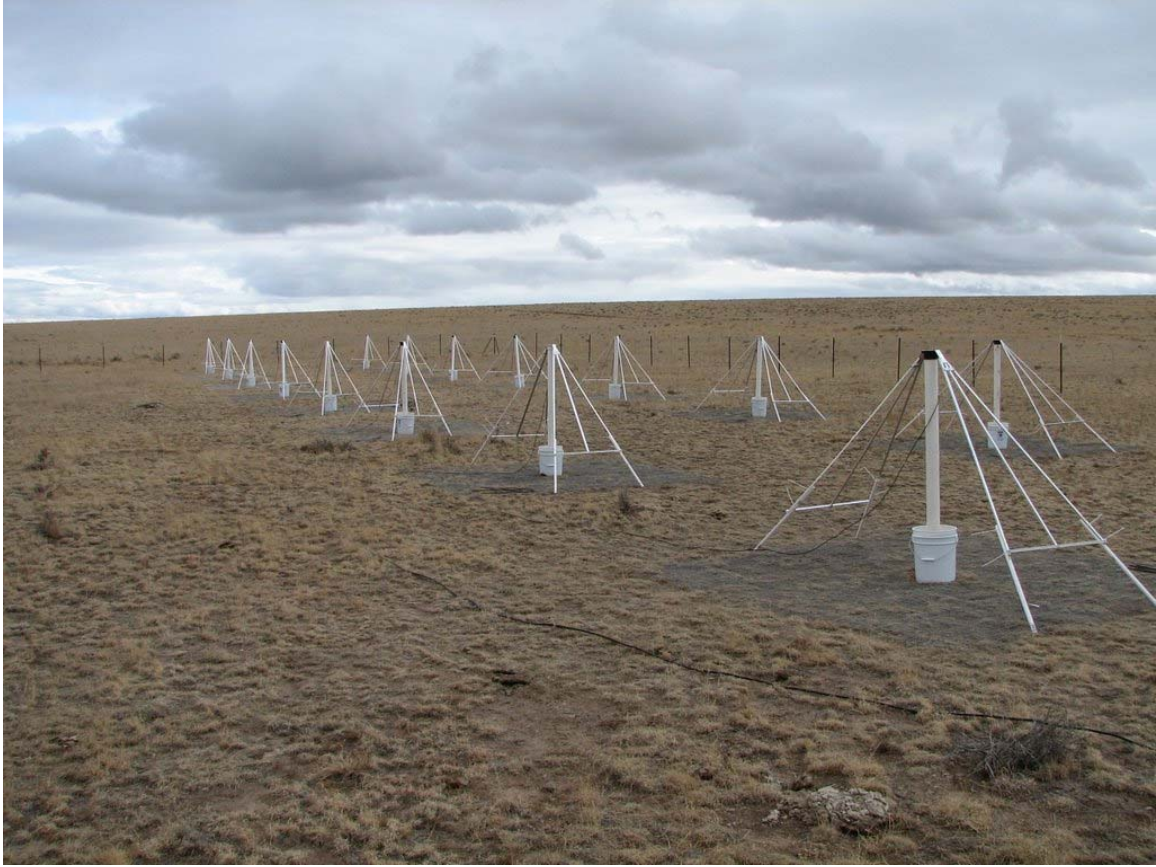
Figure 2: Single row of reconstructed and improved RTA-2 antennas. Unfortunately the improvised anchoring system using buckets of sand failed after a strong wind storm.

that future student-based work, including construction work for deployment of experimental hardware, needs to be much more closely supervised. A related lesson was to avoid deviation from an adopted design and installation plan except after very careful consideration and review. This lesson was driven home when soon after the trip a wind storm knocked over several of the RTA antennas. This was an indication that a well intentional but insufficiently tested deviation in the anchoring system from the original antenna installation plan had failed.

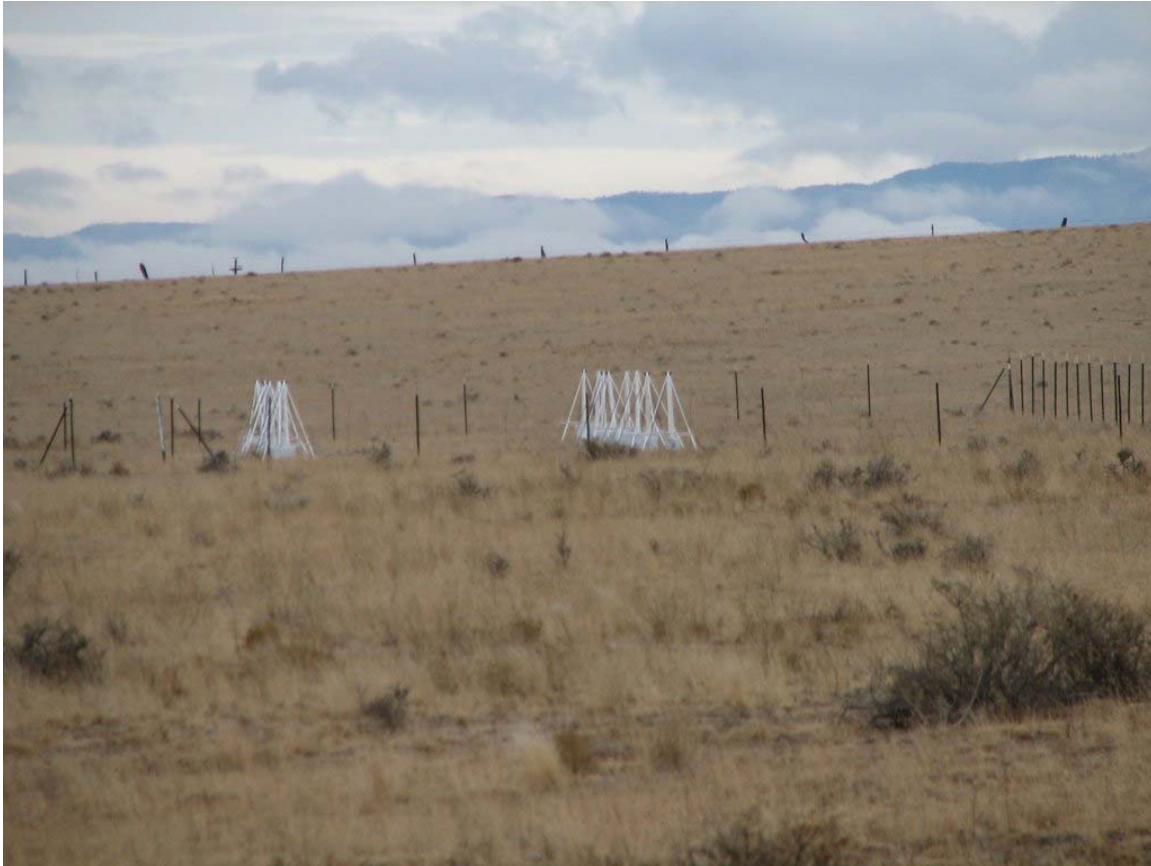
Figure 3: Two parallel rows of RTA-2 antennas.
